Manhole Inspection Summary

Manhole # S39UU_011MH

Location Address: **914 30TH ST**

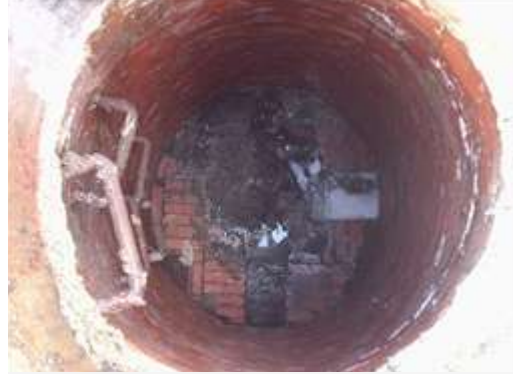
Top View

Corroded steps. Evidence of surcharge - Bench debris. Channel debris.

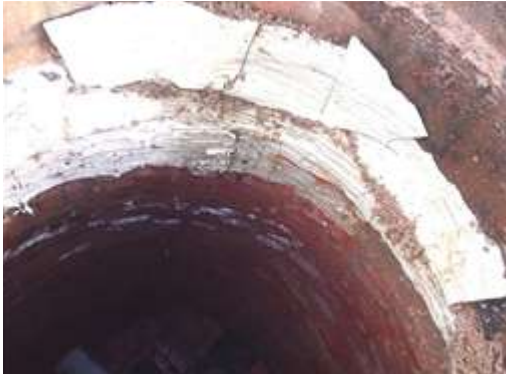
Defect

Frame leaks. Adjustment and Corbel infiltration.

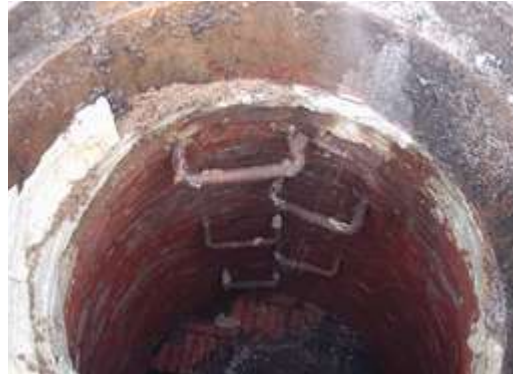
Defect

Frame leaks. Frame offset. Adjustment deterioration and infiltration. Corbel and Barrel infiltration.

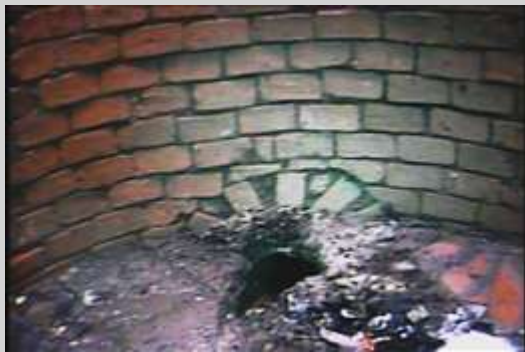
8 in. Circular Gravity Sewer Pipe Out @ 12 O'Clock

Pipe Material: **Clay** ☐ Pipe Lined

Invert Depth: **9.58** (ft.) Flow Characteristics: **Slow**

Deposits: ☐ None ☒ **Mud** ☐ Sludge ☒ **Debris** ☒ **Grease**

Silt Depth: **5** (in.) Deposits Extent: **Heavy**

Infiltration: **None** Pipe Seal Cond: **Unknown**

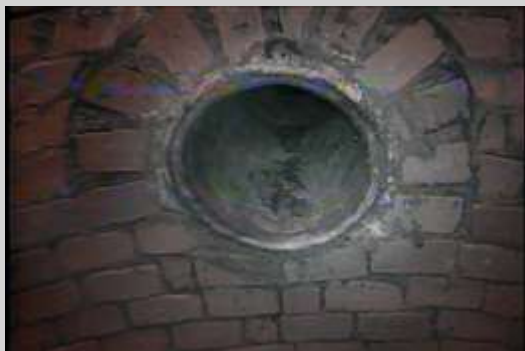
8 in. Circular Gravity Sewer Pipe In @ 3 O'Clock

Invert Depth: **7.20** (ft.) Flow Characteristics: **Slow**

Deposits: ☐ None ☒ **Mud** ☐ Sludge ☒ **Debris** ☐ Grease

Silt Depth: **5** (in.) Deposits Extent: **Heavy**

Infiltration: **Evidence** Pipe Seal Cond: **Unknown**

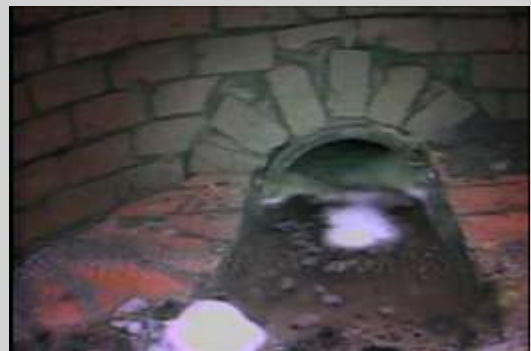
Drop In @ 3 O'Clock

Drop: **Outside** Rod and Bar

Angled: **Yes** Reading: **8.19** (ft.)

Inv Depth: **9.19** (ft.)

Drop Condition: **Open**

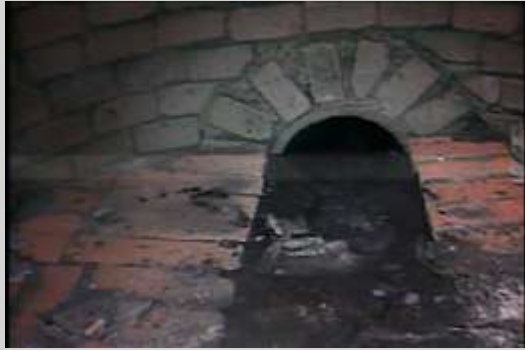
Pipe In @ 6 O'Clock

Invert Depth: **9.00** (ft.) Flow Characteristics: **Slow**

Deposits: ☐ None ☒ **Mud** ☐ Sludge ☒ **Debris** ☐ Grease

Silt Depth: **5** (in.)

Deposits Extent: **Heavy**
